Installers Guide to Avoiding Condensation in Multiwall Polycarbonate Roofing Sheet

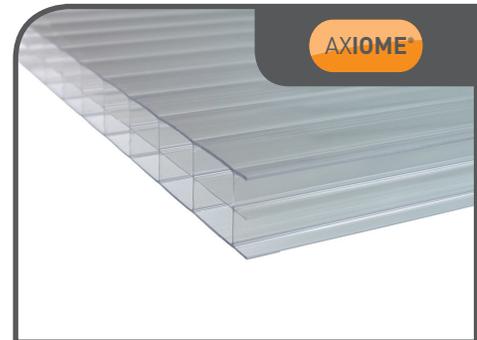
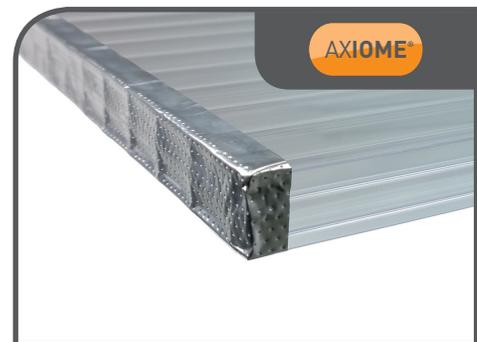
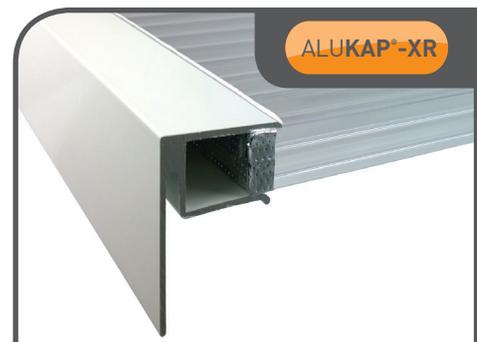
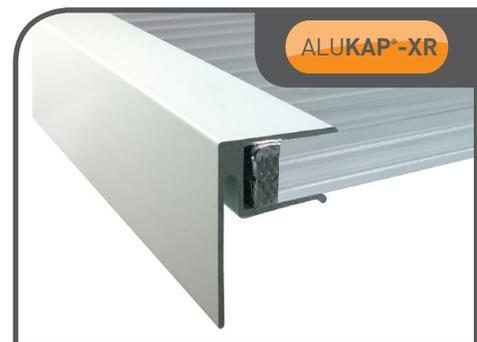
The following page illustrates how to avoid Condensation as far as possible when installing multiwall polycarbonate...

- 1 Make sure that the Axiome multiwall polycarbonate is clean and dry. If there is even small amounts of moisture in or around the sheet this could turn in to condensation once installed.

- 3 One of the most critical factors is that the drip trim itself should be of a good quality. PVC drip trims will not stand up to the extremes of the elements over time, and will loosen, warp or break, whereas Aluminium drip trims, such as Alukap-XR Endstop Bars, generally offer far greater strength and longevity in almost all situations.

- 6 Finally, the joints between the Alukap-XR Endstop Bar adjoining glazing caps must be sealed with a quality low-modulus neutral-cure compatible sealant, to ensure that no water can enter the end of the trim. Each length of Alukap-XR Endstop Bar should have been cut to the correct length and angle so that there is no gap between it and the glazing caps either side.
